Inspection Report

Report No.: CWIC2023-12-33

Sample name: Steel wheel

Item: Dynamic cornering fatigue test

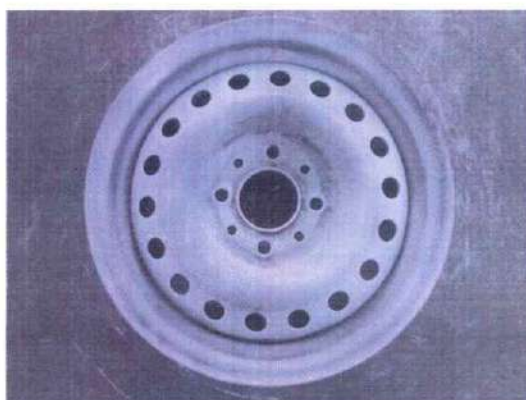
Picture 1

Accept No.	2023-806-01	Size/Model	13×5
Test load	1.741N·m	Required revolution	18,000
Initial deflection	6.58mm	Final deflection	6.61mm
Results	Achieve 18,000 revolutions with no visible cracks when sustain the test load. The load arm shaft deflection is 4%		
Final nut torque	All more than 109N·m
